I've some important questions about the M136 engine

On my 170S -1950 I've seen the **OT** symbol graved on the beveled surface of the flywheel = OK

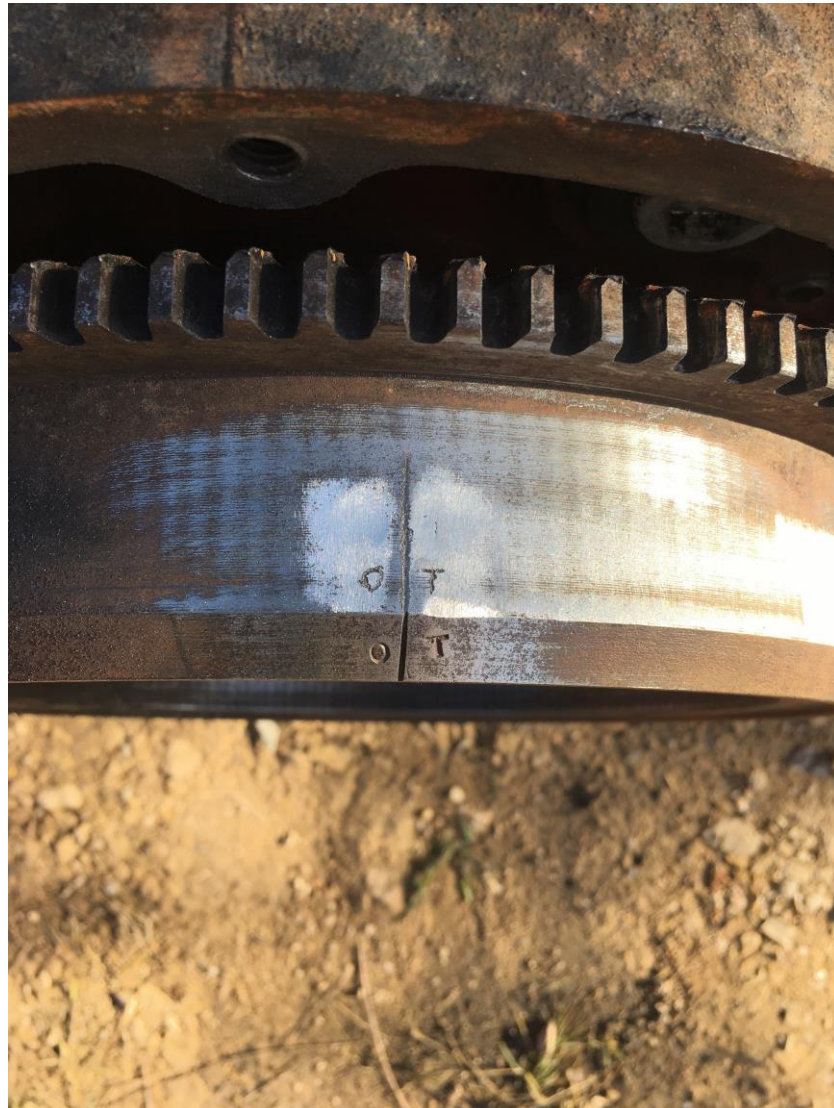
For easier work, I'd grinded in front by myself the same symbol (O I T) but on the planed face of the flywheel otherwise you can't read it with clutch case mounted

You can see now that UDC point is now in front of the hole on the clutch case , whereby stroke 1 (and also stroke 4) are on UDC = ok

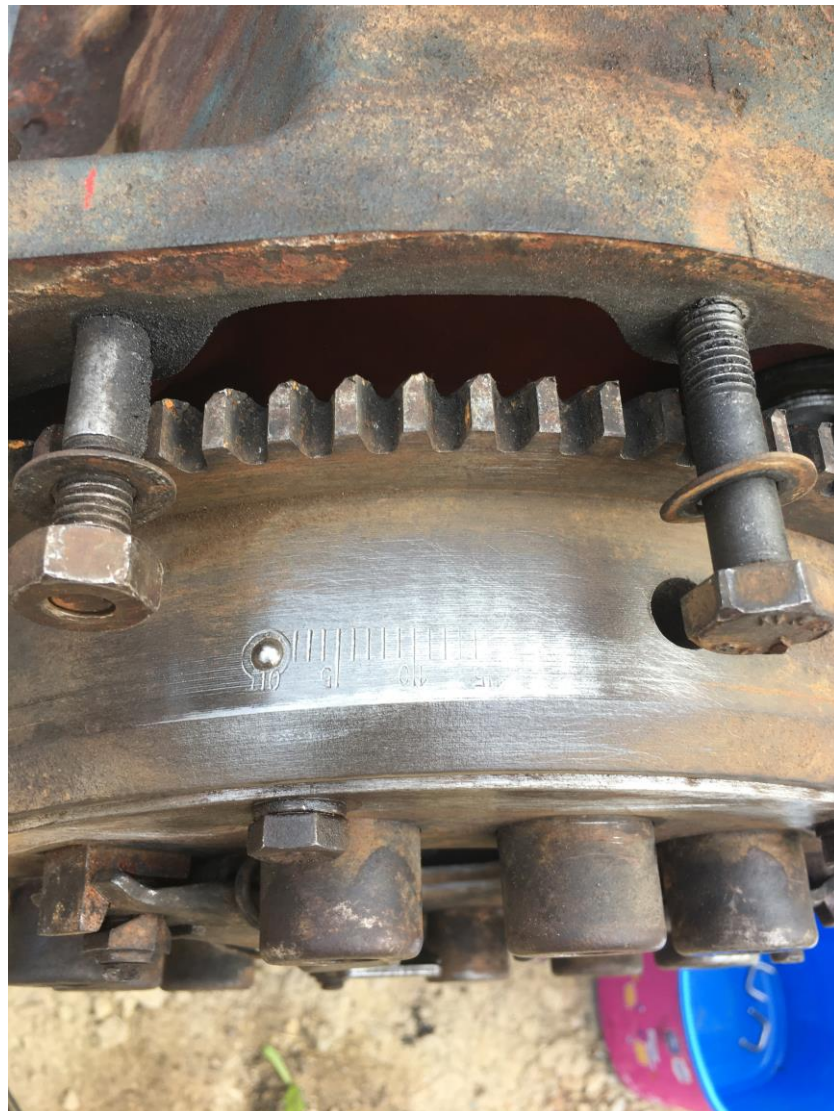
But I've seen another mark OT (marked by 180° with a ball) + numbers 5 III 10 IIII 15 III, numbers which supposed to normally help us for adjust the ignition advance for example

That another mark is named "auxiliary DC" on the repair book but auxiliary of what ???

Nowhere it's writing what is the job need to be done with that mark MB is doing a mistake on the repair manual or did that flywheel still using for another model or ????? ??
